# Laboratory Realities

## SHADE MATCHING FOR A SINGLE TOOTH USING AN ALL-CERAMIC CROWN: LABORATORY PROTOCOL

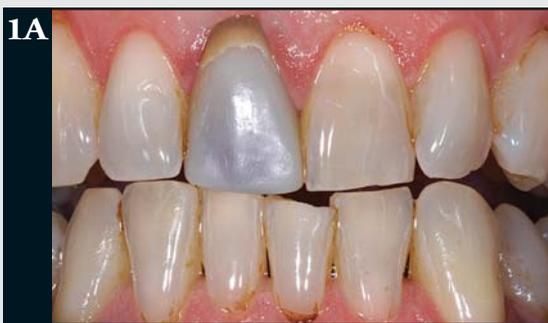
**Figure 1A.** Preoperative facial view of the patient who presented with gingival recession and a severely discolored provisional restoration on tooth #8(11).

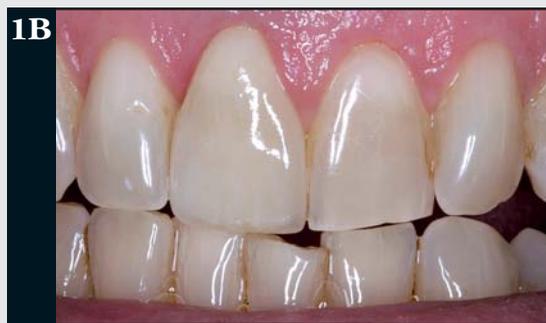
**Figure 1B.** Postoperative view of the definitive restoration of tooth #8. Note the color match and improved emergence profile of the all-ceramic crown.

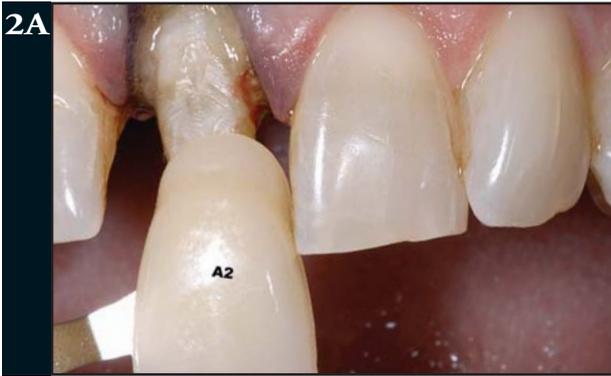
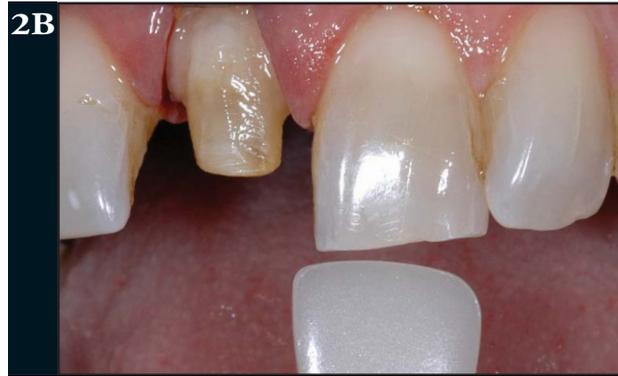
**Figures 2A,B.** Following the completion of the clinical examination, the tooth was prepared to receive an all-ceramic restoration. Shade mapping was performed by comparing shade tabs to the underlying dentin of this maxillary central incisor. Once this shade was recorded, the shade of the adjacent left central incisor was also determined. Photographs of the preparation shade were also taken and forwarded with a vinylpolysiloxane impression (ie, Aquasil, Dentsply Caulk, Milford, DE) of the prepared tooth to the dental laboratory. A provisional acrylic crown (ie, Integrity, Dentsply, Milford, DE) was placed at the site of tooth #8 while the definitive restoration was fabricated. Ensuring that each step was properly conducted would enable the authors to create a durable restoration that met the aesthetic expectations of the patient.

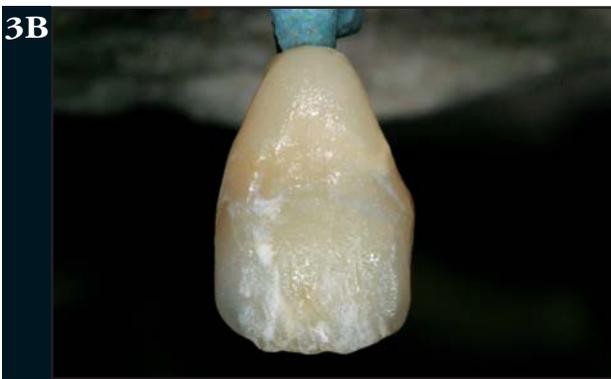
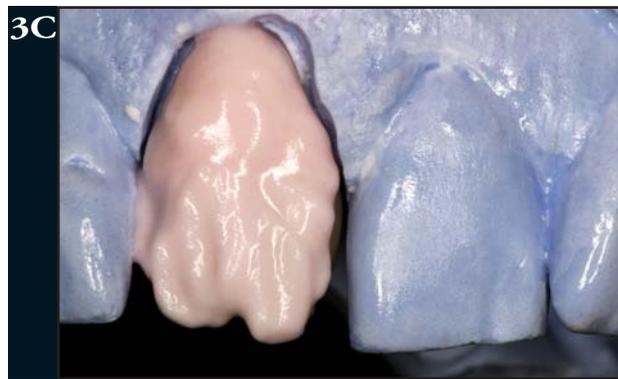
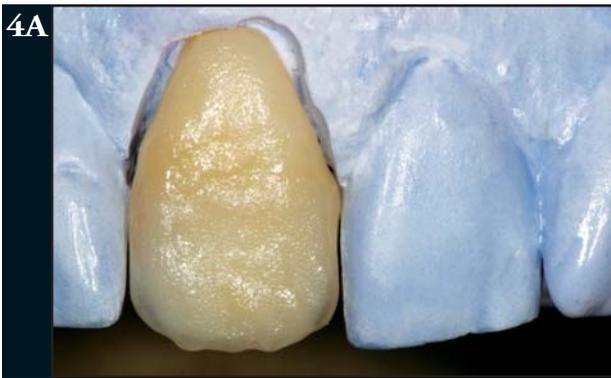
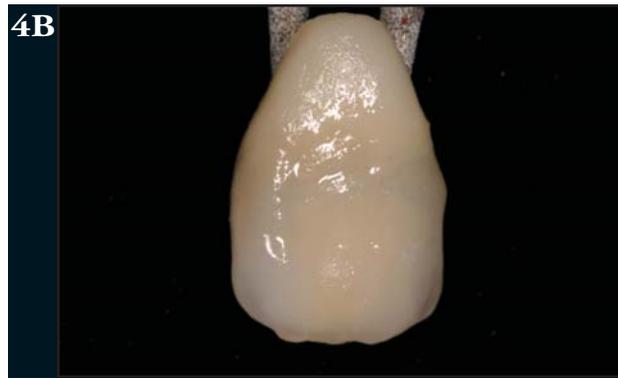
**Figures 3A,B,C,D.** Due to the complex coloring of the contralateral incisor, the clinician had requested the development of a custom shade for the restoration. In the dental laboratory, a pressed coping (shade B2) was first created for the all-ceramic restoration (ie, Initial, GC America, Alsip, IL). The coping was then examined to ensure that sufficient space would exist for the subsequent porcelain buildup. Internal characterizations of blue and gray stain were added to the incisal region, and the buildup was fired for 1 minute and held at 770° C. In the cervical third of the tooth, ceramic was added in consideration for the desired value of the restoration. A dentin-shaded C1 body ceramic was then added to the buildup. Application of a cervical porcelain A1 and a gingival body translucent modifier followed in accordance with the intended morphology of the definitive restoration.

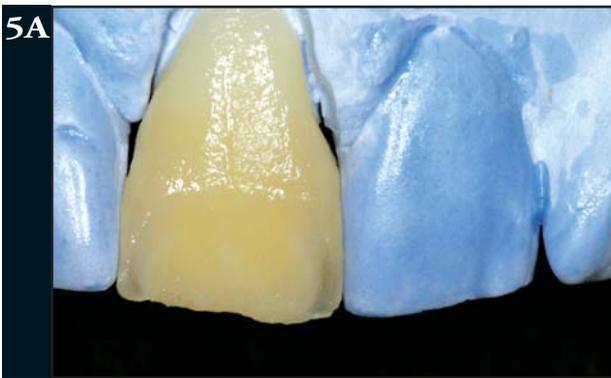
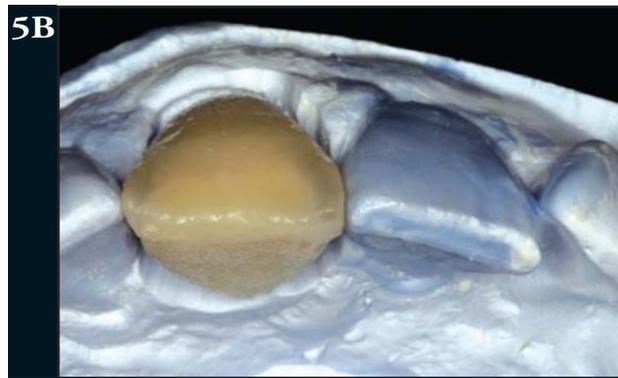
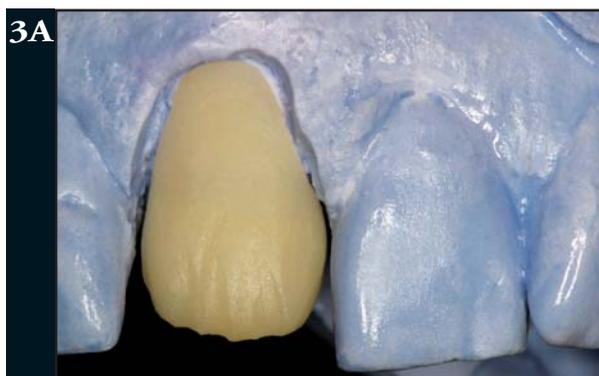
**Figures 4A,B,C.** The buildup was fired for 1 minute and held at 770° C to achieve the desired body and translucency shades. At this stage of fabrication, six different shades of porcelain were evident in the buildup. Additional porcelain CLF was added to the cervical and incisal thirds of the restoration prior to the second firing in order to replicate the effects and characterizations evident in the adjacent natural tooth. Throughout the process, all shades were carefully matched through extensive communication between the laboratory technician and the clinician.

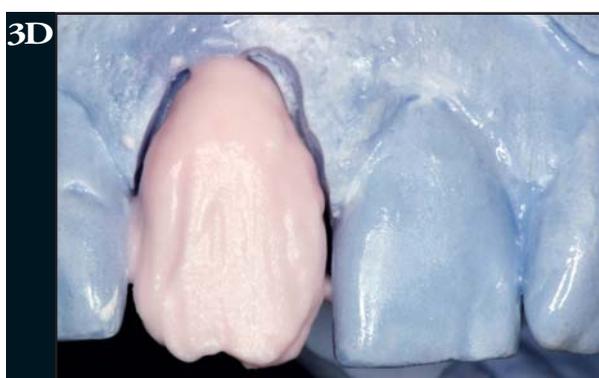
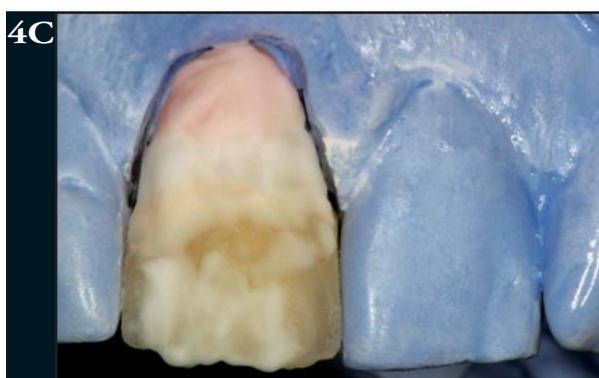
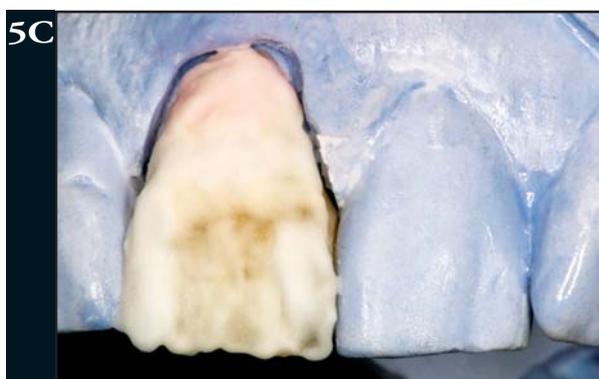
**Figures 5A,B,C.** The dentin was fired for a second time for 1 minute and held at 765° C. Following the completion of this bake, the laboratory technician verified the contour of the tooth to ensure that sufficient space existed for the final porcelain powders and the addition of mamelons. Once final colors TM 05 were added to the cervical buildup, additional ceramic powders EI 14 and EN 60 + CT22 (7:3) were added to the incisal third of the restoration.

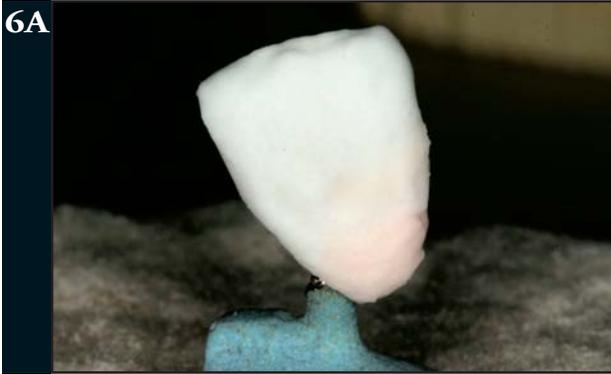
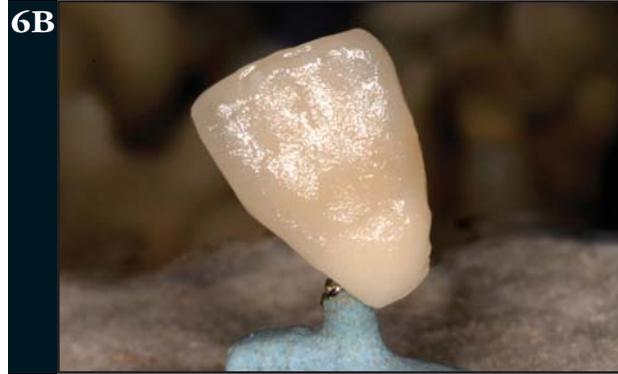
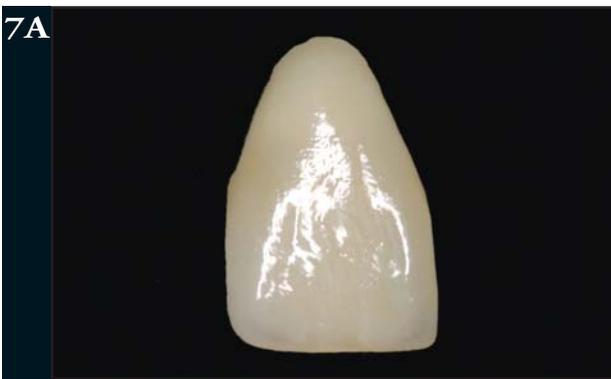
**Figures 6A,B,C.** The appearance of the buildup was again evaluated prior to firing, which was subsequently completed at a temperature of 760° C for 1 minute in a porcelain furnace. The fired restoration was then tried on the patient's model so that its contour could be verified. This represented an important step, because it not only confirmed the correct fit, but it also demonstrated the final shade of the all-ceramic crown.

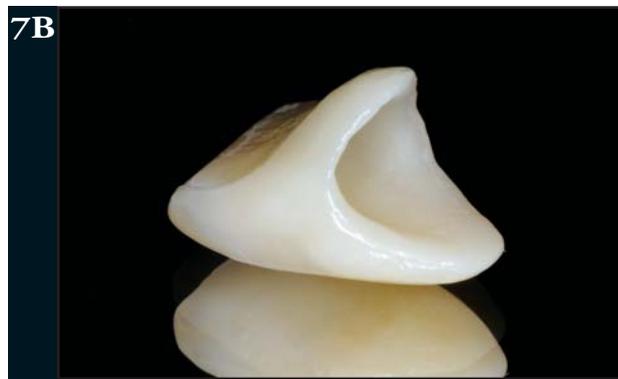
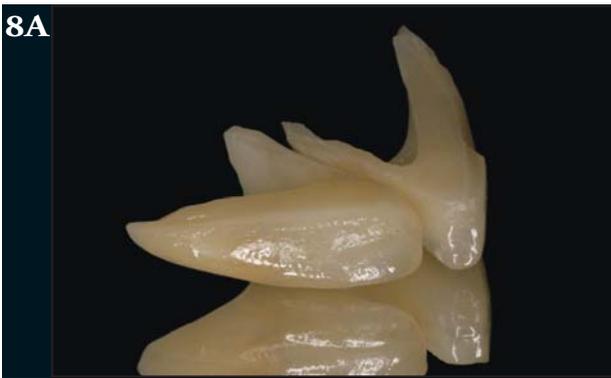
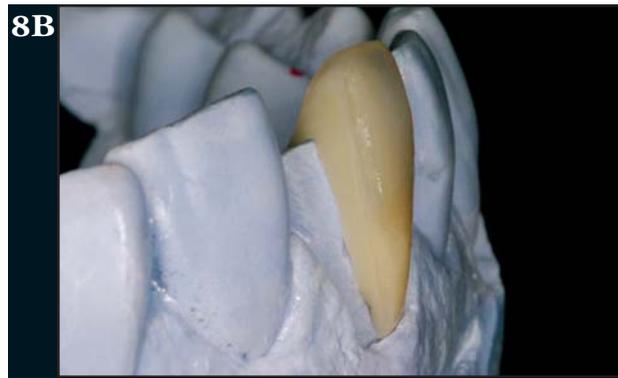
**Figures 7A,B,C.** The completed all-ceramic crown (ie, Initial, GC America, Alsip, IL) demonstrated a smooth surface texture that would, upon seating and cementation, be imperceptible from the patient's existing dentition. The full-coverage crown would be adhesively bonded to the prepared tooth following conditioning of its intaglio surface, further enhancing the long-term prognosis of this treatment. Through the use of a detailed shade mapping protocol and meticulous procedures in both the clinical setting and laboratory environment, the restoration would be seamlessly integrated with the natural teeth.

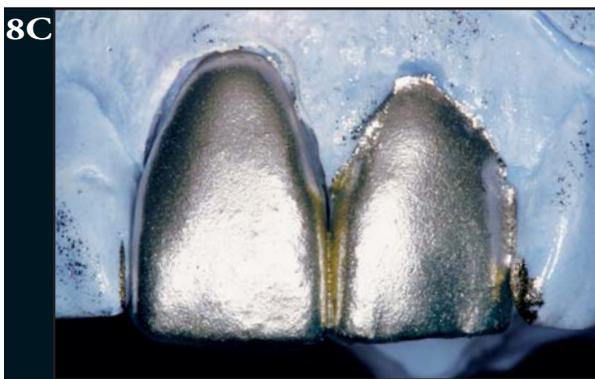
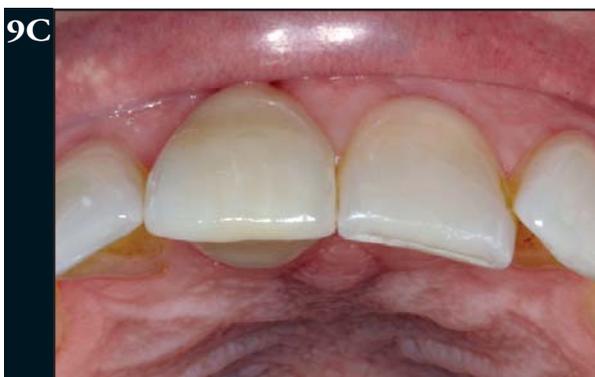
**Figures 9A,B,C.** The provisional crown restoration was removed, and the preparation was cleaned prior to try-in of the all-ceramic restoration for fit and shade match. Once the internal surface of the crown was prepared, the abutment tooth was etched and covered with a bonding agent in preparation for final bonding. The all-ceramic restoration was seated with a translucent-shaded resin cement (ie, Calibra, Dentsply Caulk, Milford, DE). Excess cement was removed after a partial cure, and the margins were cleaned and polished. Occlusion was evaluated in centric relation and centric occlusion, and the treatment was completed. Matching a single anterior crown to the shade of the natural dentition is regarded as one of the most difficult challenges in aesthetic dentistry. As demonstrated by the final outcome of this case, however, successful results can be achieved through the proper use of contemporary restorative materials, laboratory protocols, and clinical techniques.
