## CAD/CAM-FABRICATED RESTORATIONS FOR AESTHETIC REHABILITATION OF THE ANTERIOR MAXILLA

Luke Kahng, CDT\*  
James McKee, DDS†

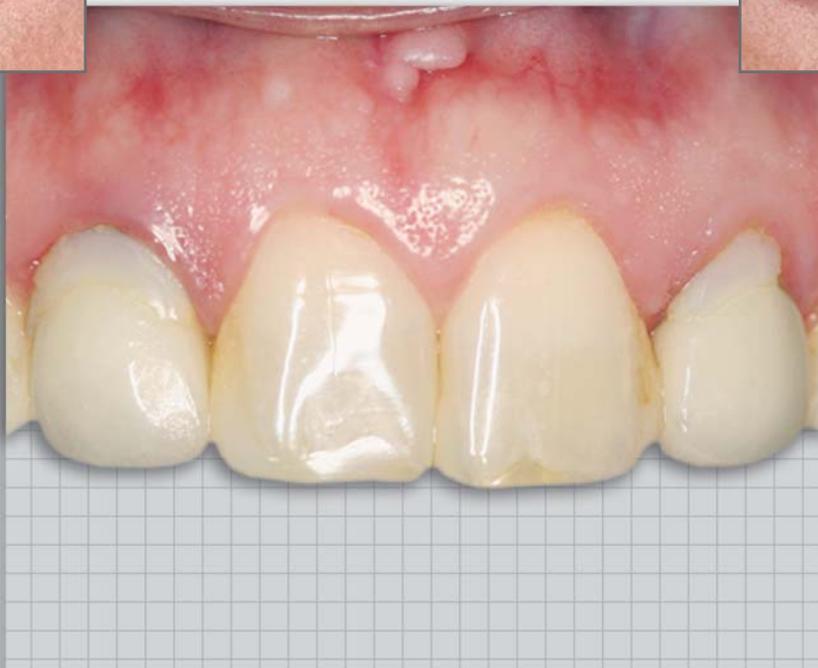
**FIGURE 2.** Removal of the preexisting restorations and re-preparation of the teeth were required.

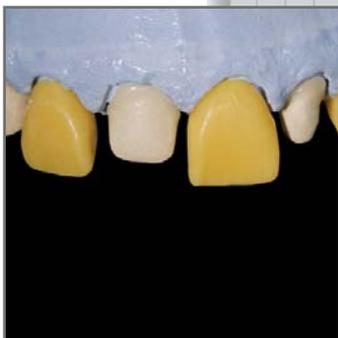
**FIGURE 8.** The zirconia copings (Etkon USA, Arlington, TX) were then examined to verify the presence of sufficient space. The development of a more aesthetically pleasing restoration required several layers of porcelain to mask the internal coloring and dark stump shades. With this in mind, the technician was required to verify that sufficient space was available to facilitate intraoral placement of the definitive restorations.

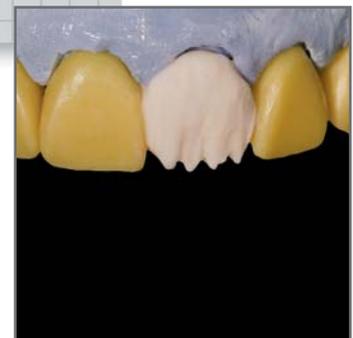
**FIGURE 10.** An A1-shaded porcelain material was layered to add dimension to the dentin regions. A cervical translucent was then placed.

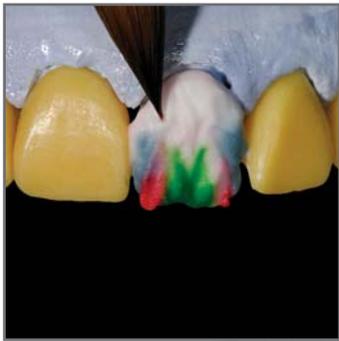
**FIGURE 11.**  
The porcelain buildup included the application of enamel effect #12 and a translucent modifier.

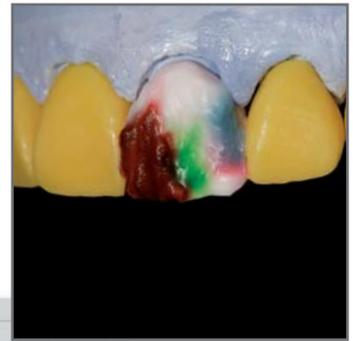
**FIGURE 12.**  
Appearance of the final porcelain layering (GC Initial ZR, GC America, Islip, IL) on tooth #9(21) prior to firing.

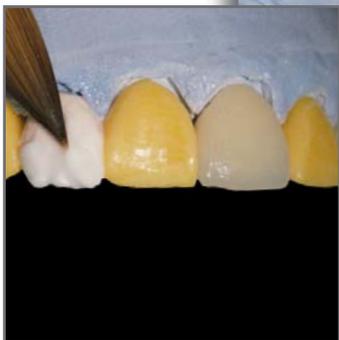
**FIGURE 13.** Occlusal view of the restorations prior to glazing. In the final evaluation, the clinician would verify occlusion in centric relation and centric occlusion. This ensured a precise and comfortable fit for the patient.

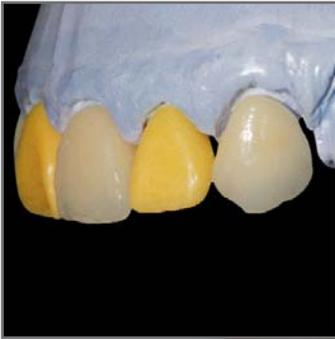
**FIGURE 16.**  
Note the natural-looking internal characterizations evident in the restorations.

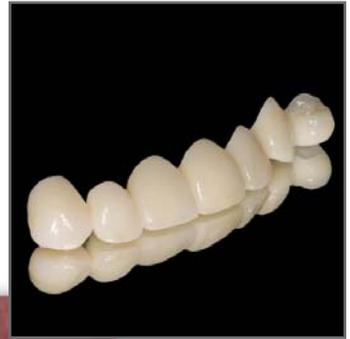
**FIGURE 17.**  
The final porcelain restorations prior to delivery.

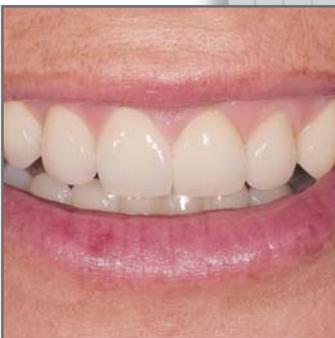
**FIGURE 18.** Postoperative appearance demonstrates natural integration and improved aesthetics. The patient was satisfied with the resultant aesthetics and function provided by the restorations. The occlusion was designed for even intensity contacts in a fully seated joint position along with anterior guidance with posterior disclusion in lateral movements. Both the right and left temporomandibular joints were a Piper 3B (lateral pole displacement that does not recapture upon opening). Given the medial pole steadiness, occlusal stability was anticipated.
