You cannot recreate what you do not see

The best way to break down a complex implant case.

BREAKING DOWN A COMPLEX ANTERIOR CASE

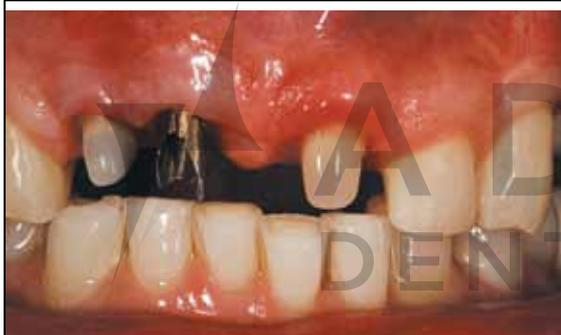
Fig. 1 Preoperative image shows #7 core built-up, titanium abutment and tooth #8 included in treatment

01 In this particular case, the 60-year-old male presented with a variety of important factors. Occlusion, shade and characterized wear were all integral to the composition of the patient's smile line esthetics. Tooth #7 had been built up with a dark intrinsic stump shade visible at its core and the interproximal gingival height lacked natural fullness at the interdental papilla.

02 An implant replacement for tooth #8 required consideration of proper material selection when noting the wear of the lower protrusive function in occlusion. Additionally, #9 required characterizing esthetics to include crack lines mimicking the natural surrounding dentition, which showed prominence of crack lines from heavy functional and parafunctional loading. Given the dynamics of the varying requirements with respect to design of the restorations and their intended use, the treatment plan needed to

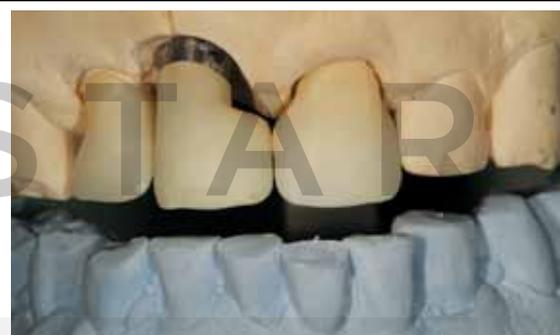
Fig. 3 Milled substructure try-in assessment

05 CAD/CAM designed, motion-milled Amann Girrbach zirconium copings were fabricated with high translucency zirconium blocks to include lingual backings and longer incisal edge lengths for the substructure of all three crowns. They were then preshaded, sintered, polished, glazed and tried back onto the model to check occlusal height with the lower opposing model. The gingival margin placement and interdental papilla were assessed (**Fig. 3**).

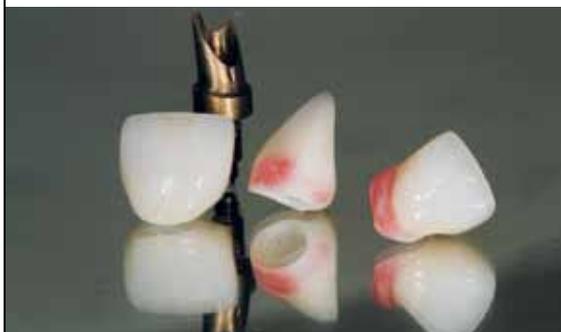
Fig. 4 Mirror image provides quality control

06 The finished build-up was layered over the copings using GC Initial ZRFS porcelain dentin shades A1 and C1 combined with enamel E-57 to required specifica-

tions. The mirror image allows greater quality control and shows the matched esthetics and the calcification characterization between the enamel and in the detailed mammelons as viewed from different angles (**Fig. 4**).

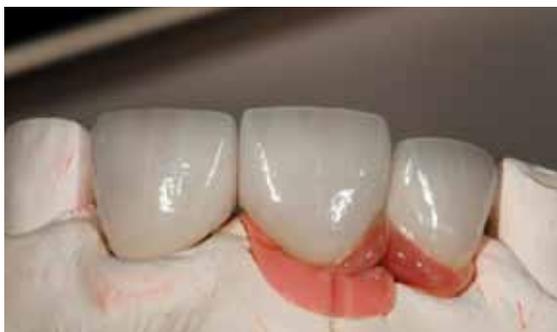
Fig. 5 Restorations seated for review of gum tissue porcelain

07 The porcelain crowns were seated back onto the model and the gum line assessed, along with the interdental papilla, for placement of the GC Initial ZR Gum shade porcelain, GM36 and GM 34, which were layered to create the shade blend from the cervical collar to the height of the gingival margin and checked for interference (**Fig. 5**).

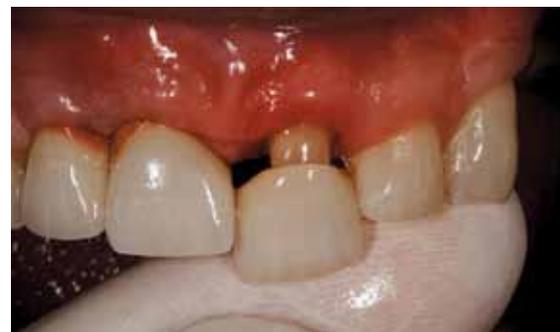
Fig. 6 Custom stain was added to interproximal and cervical aspects

08 Once completed, the patient presented for a try-in and the restorations were evaluated for custom staining. GC Initial IQ Lustre paste Body shade A was applied externally from the incisal to the gingival margin, adding warmth to the overall shade. The gum shade porcelain was reviewed for additional opacity interproximally between teeth #7 and #8 (**Fig. 6**).

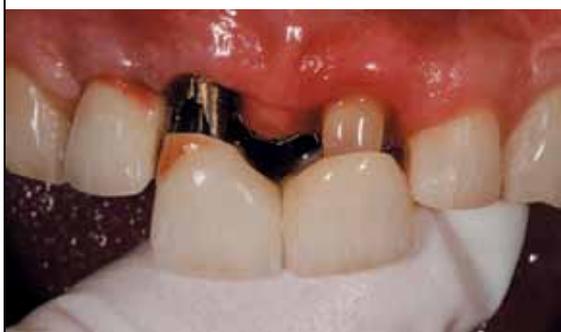
Fig. 7 Symmetry reviewed at try-in visit

09 The centrals were seated together and symmetry evaluated for specific contour and shape. The incisal length was evaluated and the mesial interproximal collar marked for adjustment and stain addition (**Figs 7 & 8**).

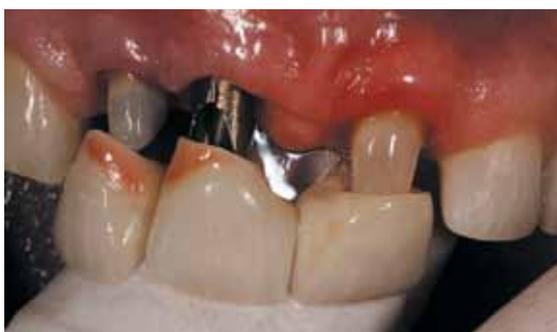
Fig. 8 Modification noted to specific contour

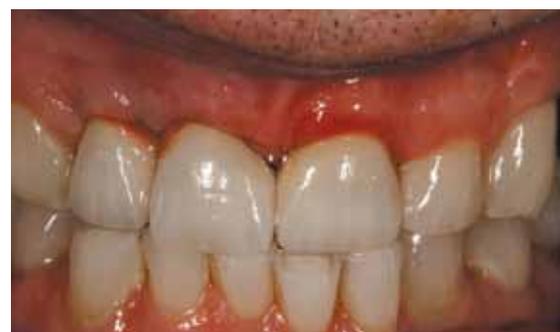
Fig. 9 Excursive pattern and tooth length are observed

10 With the teeth hydrated, the color, tone and value were reviewed, along with the width and length in harmony with the edge-to-edge contact between the upper and lower protrusive movements (**Fig. 9**).

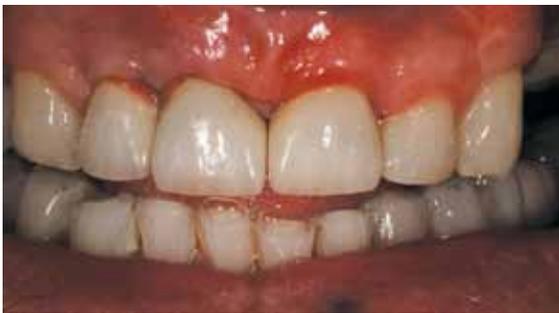
Fig. 10 Canine rise and phonetic function assessed

11 The teeth were dehydrated and with the teeth slightly apart and in canine rise, the phonetic function was evaluated (**Fig. 10**).

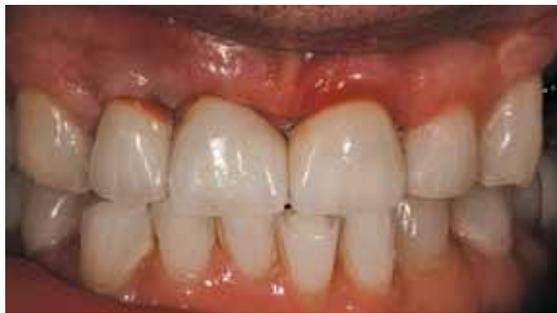
Fig. 11 Restorations seated and bite viewed in centric occlusion

12 With upper and lower arches in centric occlusion, all three restorations were placed and, with lips at rest, the patient was asked to articulate the "e" sound for proper enunciation and tongue movement over the teeth (**Figs 11 & 12**).

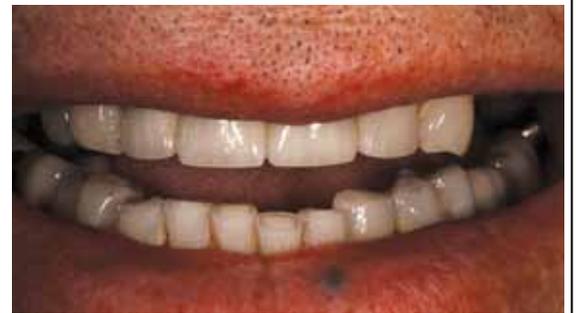
Fig. 12 Patient performed vowel sound enunciation

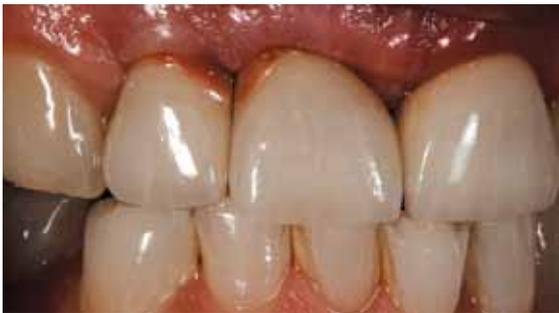
Fig. 13 Close up viewed for interproximal assimilation and canine excursion

13 Finally in close-up view, again the interproximal contour and shape was evaluated during canine excursion with all three restorations seated (**Fig. 13**). The magnified image showed the hydrated teeth with natural staining to the interproximal contacts, a perfect shade match of all three restorations and the gingival shaded porcelain created a natural contact in harmony with the patient's natural gingival line. The crack lines mimic the lower incisal characterization with just the right placement (**Fig. 14**).

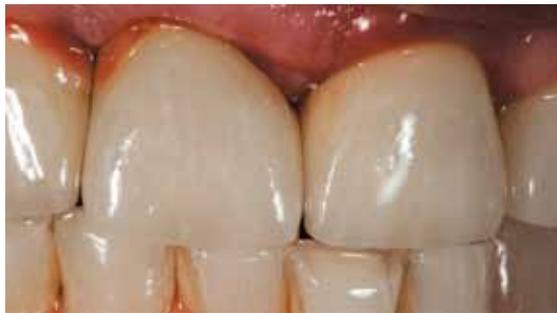
Fig. 14 Magnified image showed detail of contour, shape and characterization

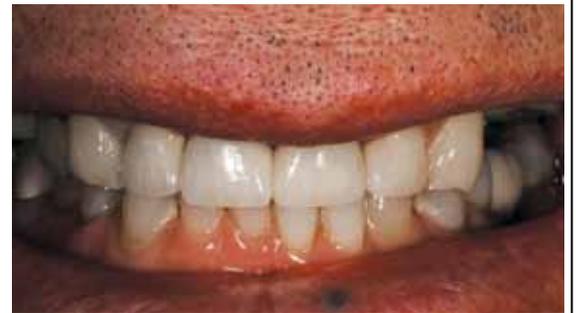
Fig. 15 Cemented restorations with patient lips at rest

14 The final cementation of the restorations occurred once they were placed and with teeth occluded; the natural looking esthetics showed teeth appropriately placed in relationship to the canine rise and the lateral excursion relieved (**Fig. 15**).
