CAD/CAM-FABRICATED RESTORATIONS FOR AESTHETIC REHABILITATION OF THE ANTERIOR MAXILLA

Luke Kahng, CDT*
James McKee, DDS†

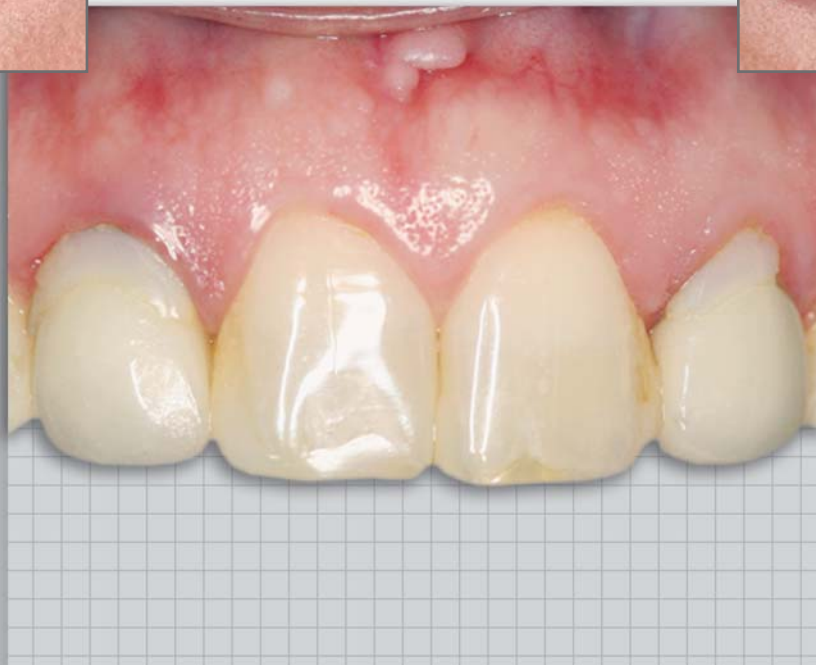
FIGURE 3. Preoperative view demonstrates compromised margins and a lack of harmony in the aesthetic zone. Although these eight teeth had been restored in the past, they were all small with decreased tooth width and height. The lateral incisors had already been crowned, and the central incisors and canines were previously restored with composite. The first premolars also had composite treatment as well as large amalgam restorations in the aesthetic zone. It was, therefore, decided to perform a more definitive full-coverage restoration with improved aesthetics.

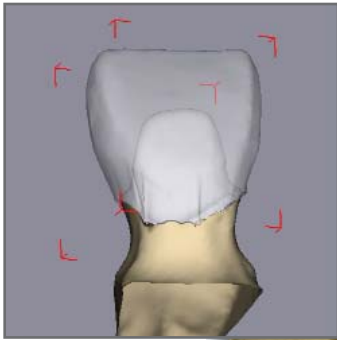
FIGURE 5. The use of a diagnostic waxup allows verification of aesthetics and desired parameters.

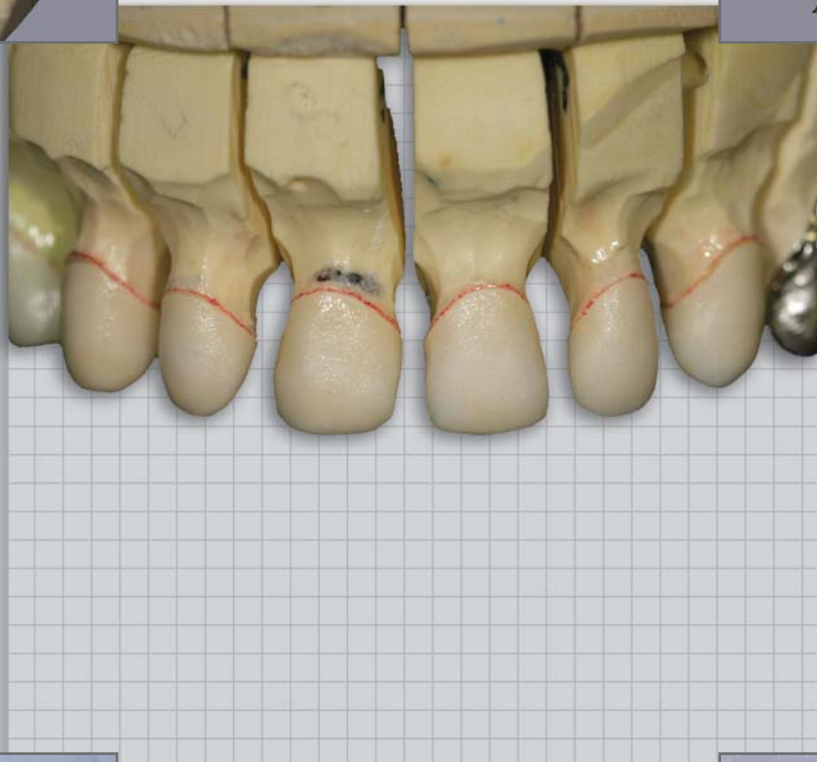
FIGURE 7. The CAD software was then used to ensure proper width and contours within the proposed restoration.

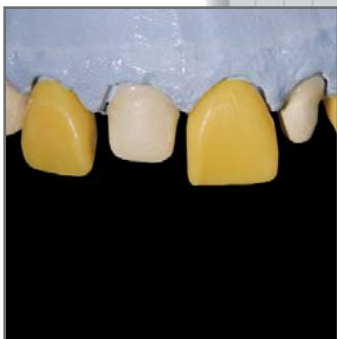
FIGURE 8. The zirconia copings (Etkon USA, Arlington, TX) were then examined to verify the presence of sufficient space. The development of a more aesthetically pleasing restoration required several layers of porcelain to mask the internal coloring and dark stump shades. With this in mind, the technician was required to verify that sufficient space was available to facilitate intraoral placement of the definitive restorations.

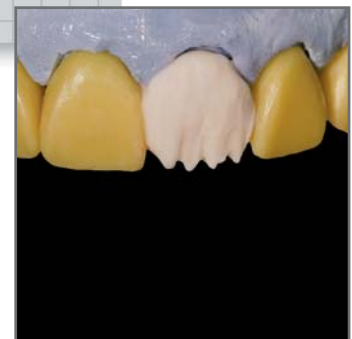
FIGURE 9. A full-contour waxup was then created to allow proper buildup during the laboratory phase.

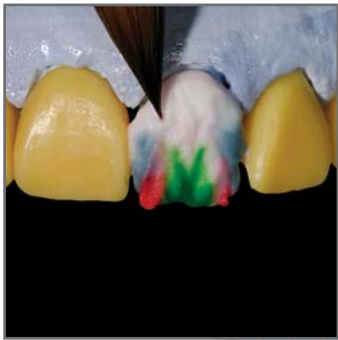
FIGURE 10. An A1-shaded porcelain material was layered to add dimension to the dentin regions. A cervical translucent was then placed.

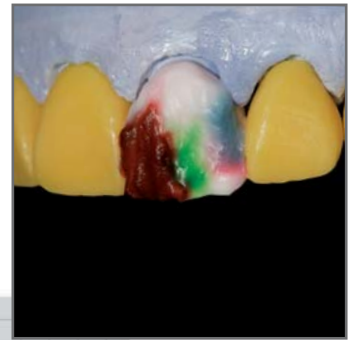
FIGURE 11.
The porcelain buildup included the application of enamel effect #12 and a translucent modifier.

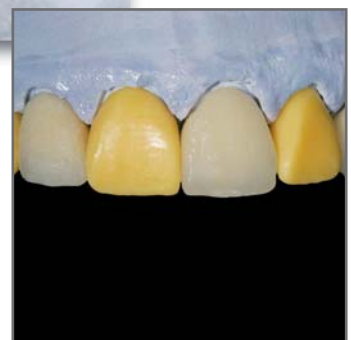
FIGURE 14.
Application of an enamel layer using an artist's brush.

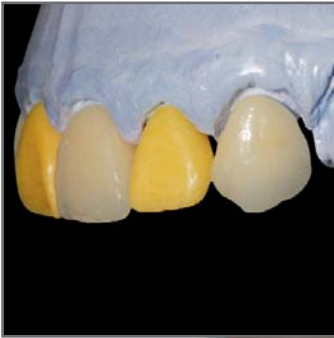
FIGURE 15.
Surface texture and characterization were verified prior to the addition of final luster.

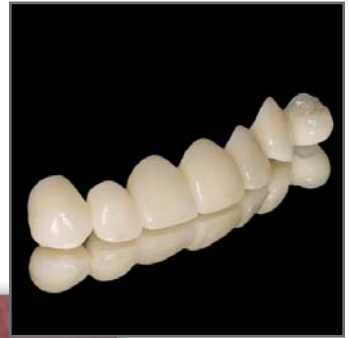
FIGURE 16.
Note the natural-looking internal characterizations evident in the restorations.

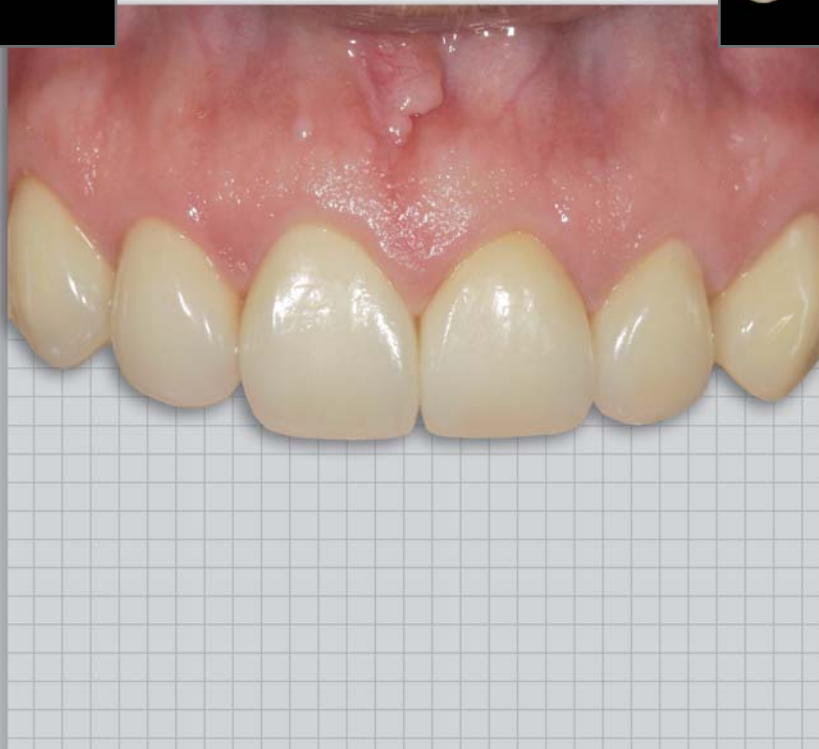
FIGURE 17.
The final porcelain restorations prior to delivery.

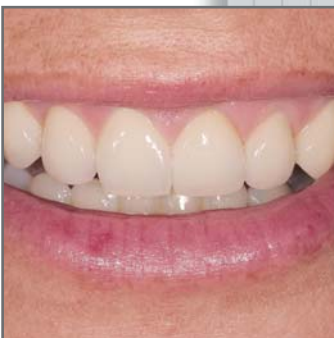
FIGURE 18. Postoperative appearance demonstrates natural integration and improved aesthetics. The patient was satisfied with the resultant aesthetics and function provided by the restorations. The occlusion was designed for even intensity contacts in a fully seated joint position along with anterior guidance with posterior disclusion in lateral movements. Both the right and left temporomandibular joints were a Piper 3B (lateral pole displacement that does not recapture upon opening). Given the medial pole steadiness, occlusal stability was anticipated.

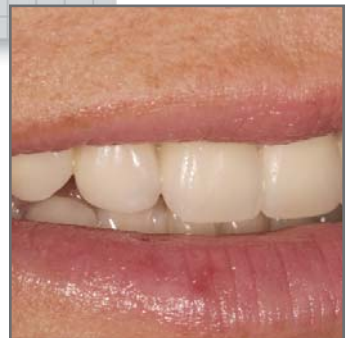
FIGURE 20.
Postoperative appearance. Note the harmonious length and contour evidenced by the restorations.
