Solving a Large Space in the Anterior

In this unusual case, a small no-prep veneer offered the patient a more esthetic smile.

By Luke Kahng, CDT

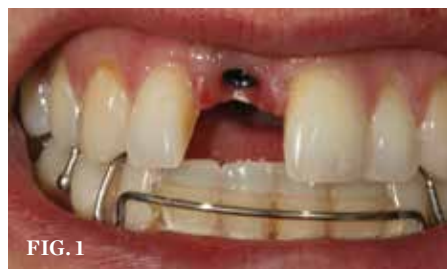
FIG. 1

TREATMENT STEPS (1.) The zirconia abutment for tooth No. 8. **(2.)** A GC shade tab was used to match the incisal one third.

The clinician prescribed a zirconia crown and abutment for the patient's tooth No. 8 (Figure 1). The gap between tooth No. 7 and tooth No. 8 was larger than normal, creating an unesthetic appearance. With that large a space to fill, the two centrals could not match in size. The technician mentioned his concerns to the patient, who was in agreement. He then recorded her color, using GC shade tabs (GC America, www.gcamerica.com), noting especially the incisal one third (Figure 2).

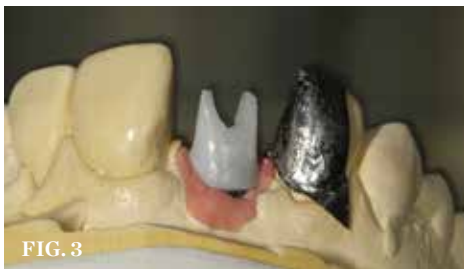
LAB AND CLINICAL STEPS (3.) Platinum foil on the cast. (4.) Porcelain application on tooth No. 7. (5.) Layered enamel on top of the foil in the patient's mouth. (6.) The finished restoration as shown on the mirror. (7.) The initial try-in stage. (8.) Immediate shot showing the veneer and crown side by side. (9.) The try-in veneer alone. (10.) The final restoration after light-curing and bonding.

On the cast model, he used 0.001 thickness of platinum foil. He then burnished the foil onto the veneer on the model (Figure 3). With the foil still in place, he applied porcelain to the veneer. For excellent color with the zirconia restorations, the author uses GC Initial ZR Porcelain. The porcelain was applied to the very small veneer with enamel and translucency twice, after the first and second bakings (Figure 4). The author first layered enamel on top of the foil on the cast model (Figure 5), then placed it into the patient's mouth with the foil still in place. The concept was to make it thicker and decrease the width of tooth No. 8 in doing so. This effort would thereby save the patient's natural
