Solving a Large Space in the Anterior

In this unusual case, a small no-prep veneer offered the patient a more esthetic smile.

By Luke Kahng, CDT

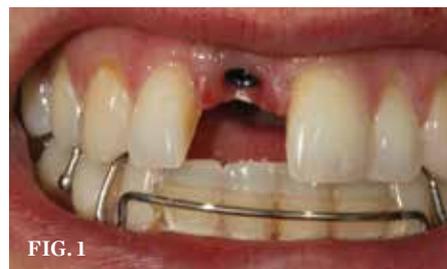
FIG. 1

The clinician prescribed a zirconia crown and abutment for the patient's tooth No. 8 (Figure 1). The gap between tooth No. 7 and tooth No. 8 was larger than normal, creating an unesthetic appearance. With that large a space to fill, the two centrals could not match in size. The technician mentioned his concerns to the patient, who was in agreement. He then recorded her color, using GC shade tabs (GC America, www.gcamerica.com), noting especially the incisal one third (Figure 2).

TREATMENT STEPS (1.) The zirconia abutment for tooth No. 8. **(2.)** A GC shade tab was used to match the incisal one third.

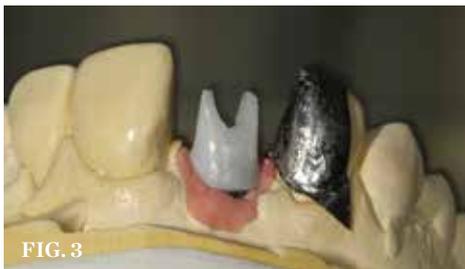
On the cast model, he used 0.001 thickness of platinum foil. He then burnished the foil onto the veneer on the model (Figure 3). With the foil still in place, he applied porcelain to the veneer. For excellent color with the zirconia restorations, the author uses GC Initial ZR Porcelain. The porcelain was applied to the very small veneer with enamel and translucency twice, after the first and second bakings (Figure 4). The author first layered enamel on top of the foil on the cast model (Figure 5), then placed it into the patient's mouth with the foil still in place. The concept was to make it thicker and decrease the width of tooth No. 8 in doing so. This effort would thereby save the patient's natural

LAB AND CLINICAL STEPS (3.) Platinum foil on the cast. **(4.)** Porcelain application on tooth No. 7. **(5.)** Layered enamel on top of the foil in the patient's mouth. **(6.)** The finished restoration as shown on the mirror. **(7.)** The initial try-in stage. **(8.)** Immediate shot showing the veneer and crown side by side. **(9.)** The try-in veneer alone. **(10.)** The final restoration after light-curing and bonding.

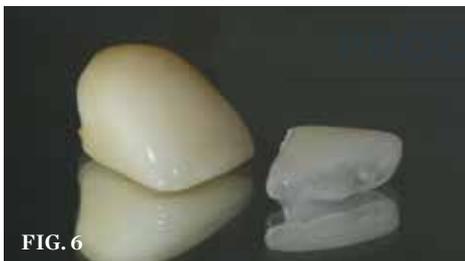
A mirrored image of the finished crown and no-prep veneer was viewed (Figure 6). Maximum translucency was created with GC IQ Lustre Paste L3. In the initial try-in stage, it was apparent exactly how small and thin the veneer was (Figure 7) and how it eventually fit over the patient's natural tooth. An immediate shot (Figure 8) showed side-by-side how well the veneer and crown fit together in the mouth. The veneer seen alone makes clear exactly how small an area it covered (Figure 9). For harmony and blended colorization check, the author photographed a side view of the patient's dentition. In the final view, after light-curing and bonding, the patient was again photographed (Figure 10).
