Luke S. Kahng, CDT

Visualize and achieve

Seeing the final outcome for a tricky case.

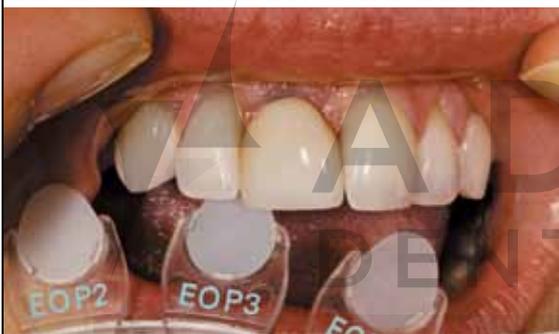
Fig. 1 Custom shade match to determine most esthetic outcome.

01 During the custom shade match it was determined that the symmetry of the temporary when compared to #9 was not conducive to an esthetic final outcome and that higher esthetics could be obtained via modifications. A custom shade match was done at this time. #9 showed a high opacity in an A3 range along with B0 mixture with enamel (Fig. 1). Incisal 1/3 has some staining with subtle gray, white-ish, orange, and tan modifications.

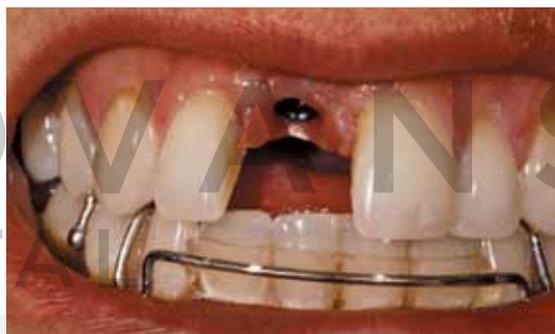
Fig. 2 Denotes post temporary removal showing a large gap between #8 and #9 as well as #7 and #8.

02 Figure 2 denotes post temporary removal showing a large gap between #8 and #9 as well as #7 and #8. Careful attention must be paid to the interproximal contacts to avoid black triangles.

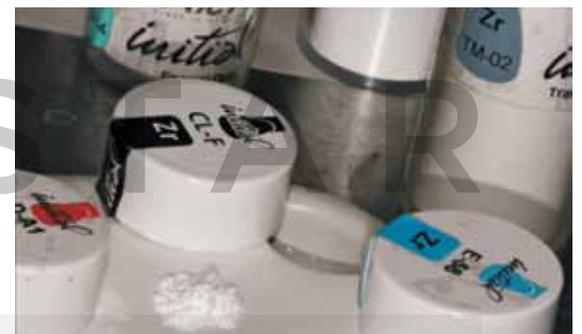
Fig. 3 GC Initial porcelain was utilized followed by an 810 Celsius body bake.

03 GC Initial porcelain was utilized followed by an 810 Celsius body bake. (Fig. 3) And the zirconia abutment produced using the Motion Mill 2 (Fig. 4).

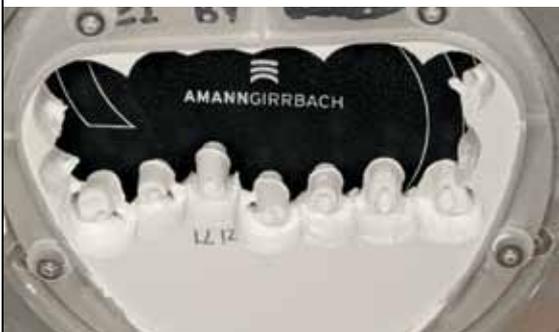
Fig. 4 The zirconia abutment produced using the Motion Mill 2.

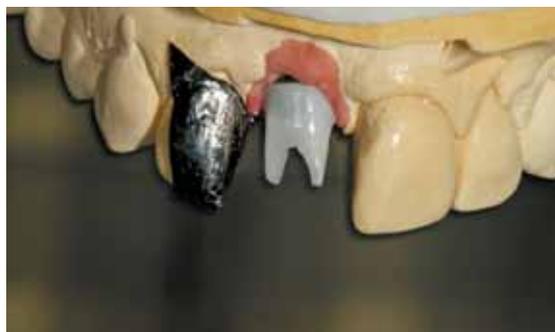
Fig. 5 Using platinum foils 0.001 thickness, #7 is simply wrapped.

04 Using platinum foils 0.001 thickness, #7 is simply wrapped. No preparation will be necessary as this will be produced along the mesial gingival areas to act as a filler and achieve proper symmetry (Fig. 5).

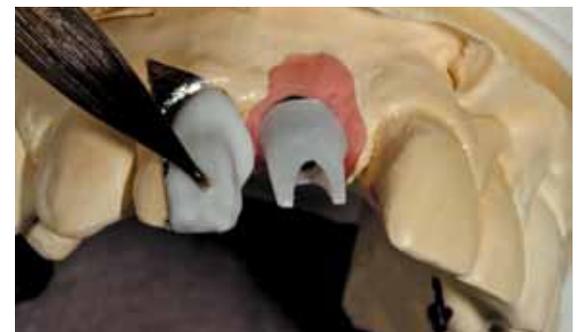
Fig. 6 Build up with CL-F.

05 Build up with CL-F. Added to the mesial of #7 dentin A3 and E58 to match natural dentition of tooth

#7. Apply CL-F and dentin A3 (Fig. 6).

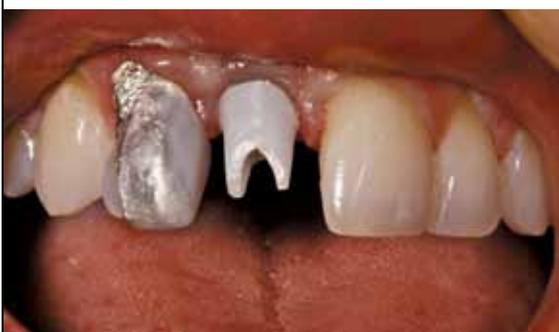
Fig. 7 Try in of abutment before removal of foil to establish final fit.

06 Figure 7 shows the try in of abutment before removal of foil to establish final fit

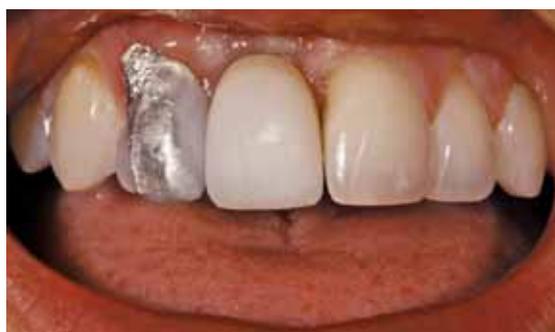
Fig. 8 Inserted #8 in bisque bake stage to make sure that the modifications were successful.

07 Tooth #8 was inserted in bisque bake stage to make sure that the modifications were successful (Fig. 8).

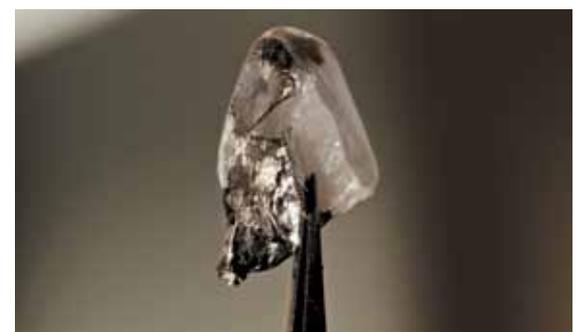
Fig. 9 Removal of foil.

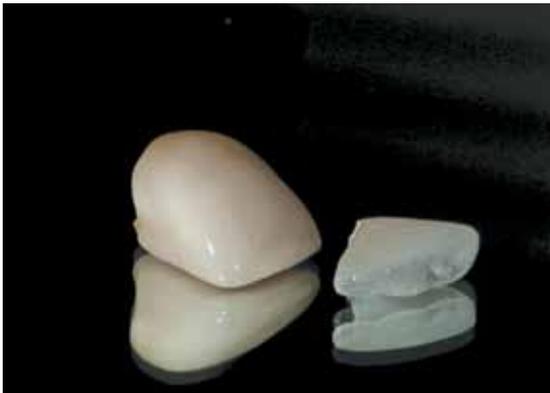
Fig. 10 No-prep veneer and zirconia crown; ready for final insertion.

08 Figure 10 shows the no-prep veneer and zirconia crown and ready for final insertion.

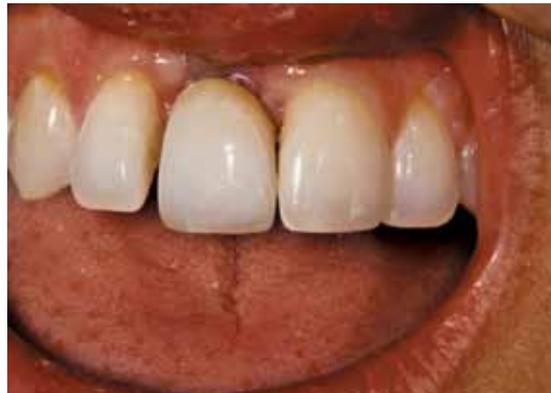
Fig. 11 Crown delivered for try in but still was in need of a touch up adjustment to the shade.

09 The crown was delivered for try in, but still was in need of a touch up adjustment to the shade.

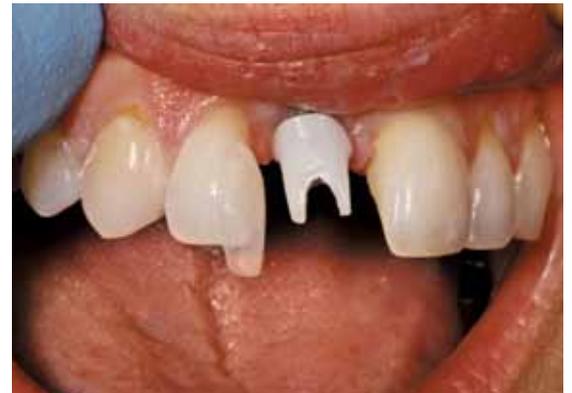
Fig. 12 Try in no prep veneer. Notice the high translucency in the final restoration.

10 Figure 12 shows the try in with no prep veneer. Notice the high translucency in the final restoration. This creates a natural hue to show through enabling a higher success in adjacent area shade match.

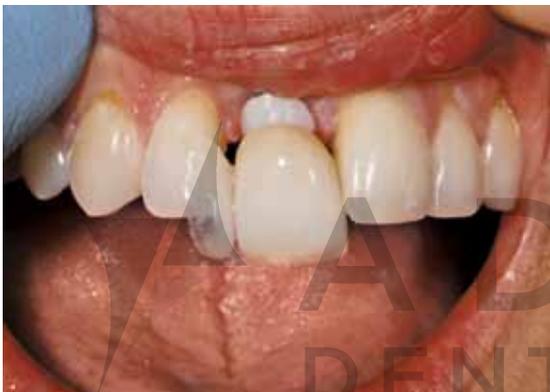
Fig. 13 Try in of final restorations.

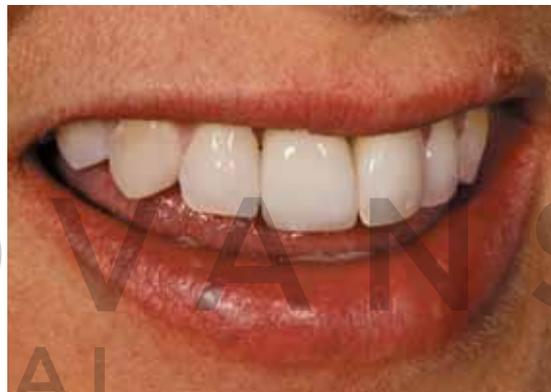
Fig. 14 Notice the beautiful harmonious shade and symmetry.

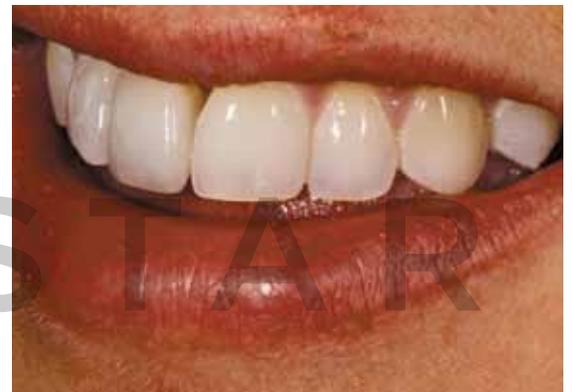
Fig. 15 Side view of final restoration.
